DEVELOPMENT APPLICATION

PROPOSAL: Hours of Operation & Signage (Vehicle Fuel and Sales)

LOCATION: 86 Clarence Street, Bellerive

Facade update, coffee shop & signage
84-88 Clarence Street, Bellerive, 7018

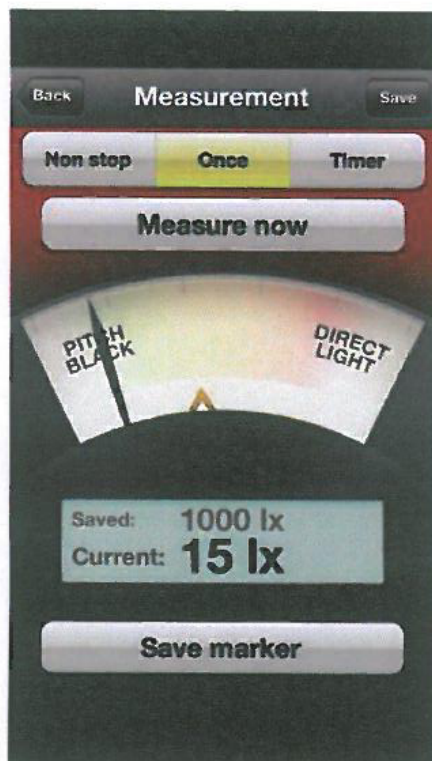
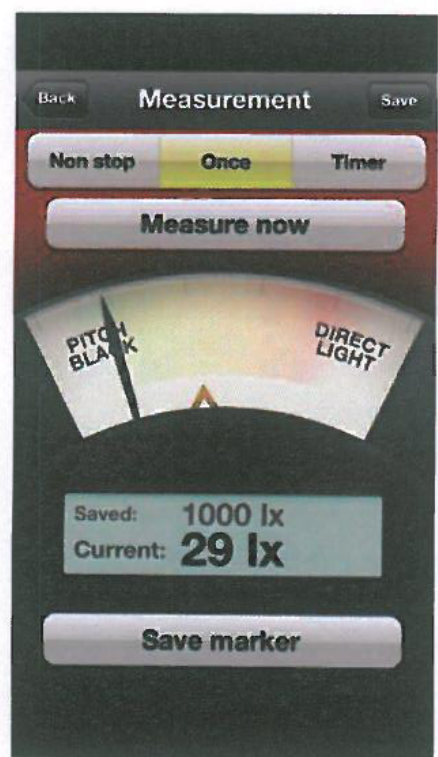
The nearest habitable room window is approximately 15 m from the canopy lighting, with the next closest about 20 m away. Both are located on a neighbouring property to the west. Given existing lighting conditions from streetlights and vehicles, and the presence of internal window treatments, any light spill is expected to result in negligible additional impact.

500mm Distance

2 Metre Distance

5 Metre Distance

10 Metre Distance
of entire site
