## **DEVELOPMENT APPLICATION**

**PROPOSAL:** Dwelling

**LOCATION:** 20 Toronto Drive, Seven Mile Beach

Project:  
PROPOSED NEW RESIDENCE  
(LOT 3) 20 TORONTO DRIVE,  
SEVEN MILE BEACH

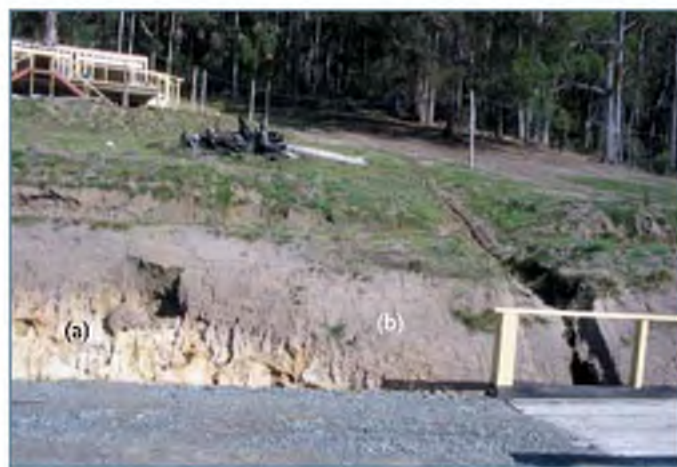
Figure 13. The severity (or sodium content) and depth of dispersive subsoils can vary considerably over short distances. (a). At this site highly dispersive subsoils exist meters away from (b) non-dispersive soils.

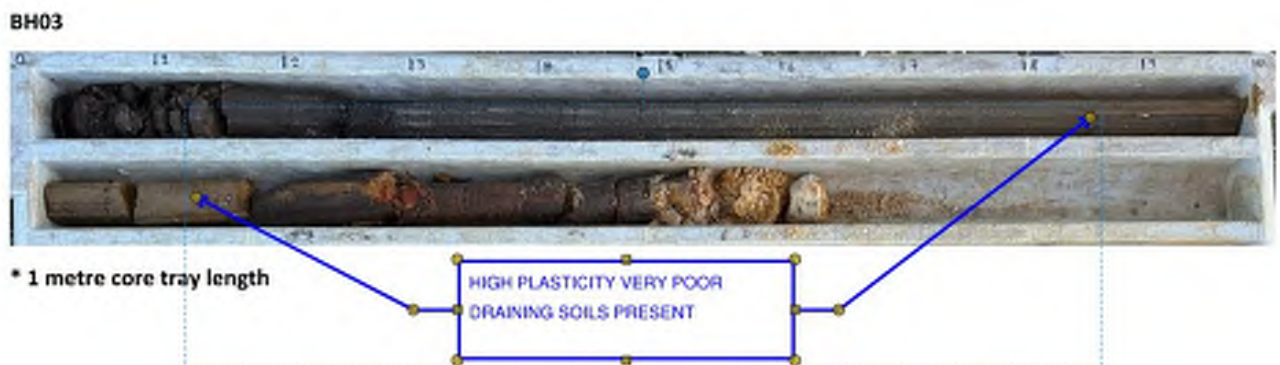
Figure 2 – Bore Hole 03 Soil Samples

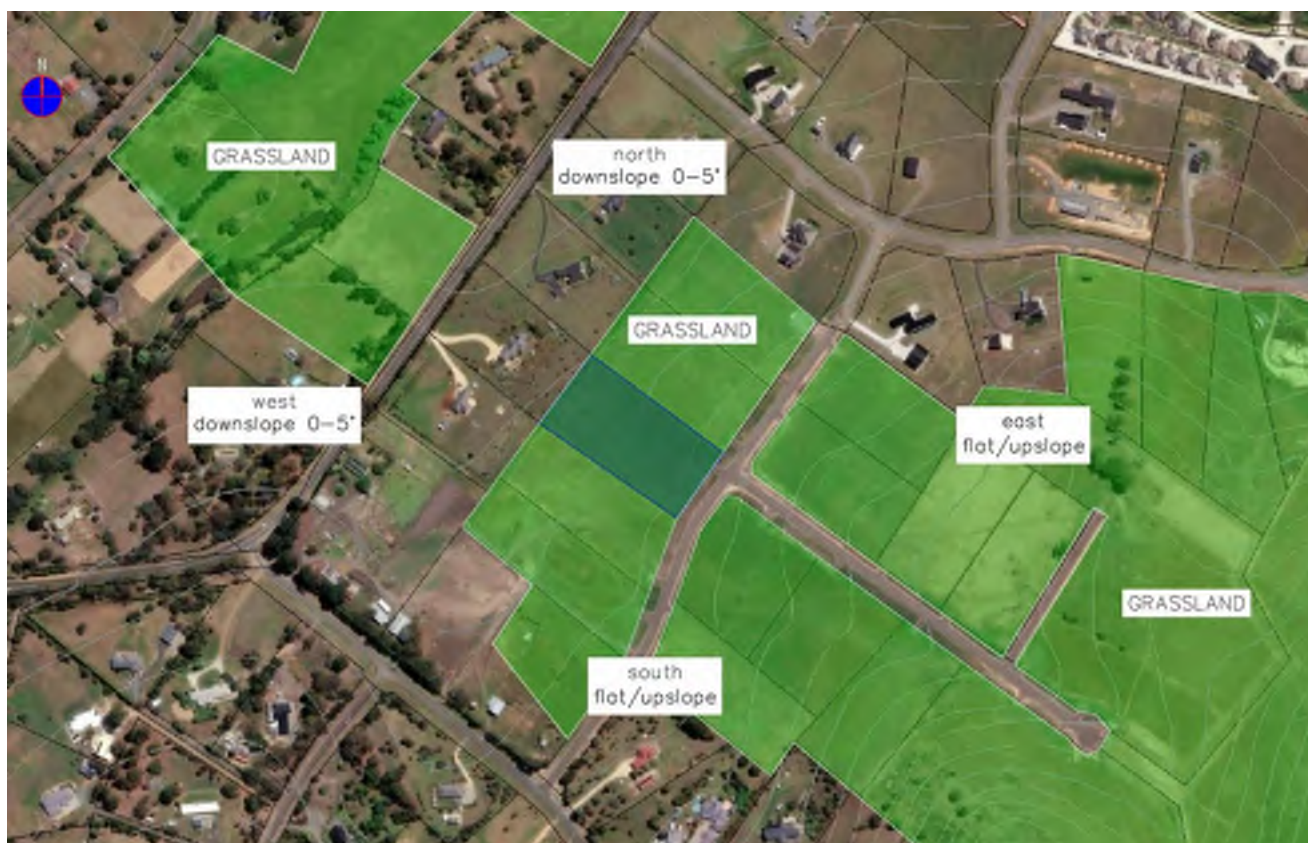
Appendix A: Photo 1 – Site analysis with cadastral overlay – Subject site highlighted blue.
