# Lauderdale Canal

## Water Quality Investigation

**Clarence City Council**

frc reference: 221004

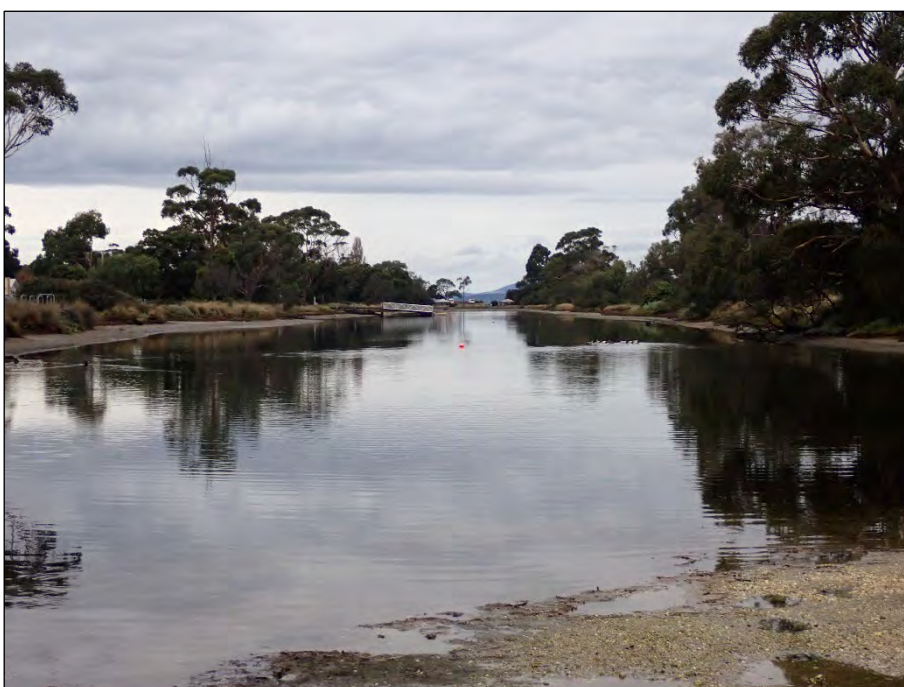
The canal does not connect to Fredrick Henry Bay to the east as originally designed, its current use is largely recreational (Figure 1.1).

Figure 1.1 A view of Lauderdale Canal looking east from South Arm Road.

Significant sediment deposits have collected in the mouth of the canal. This has resulted in reduced tidal turnover and eutrophication events leading to poor water quality and odour complaints from the public. The canal is controlled and maintained by Clarence City Council.

Consequently, it is strongly recommended that the turnover time is improved by removing sediment from the entrance channel. Modelling indicates that removing approximately 200 cubic metres of sediment from the entrance, so that there is no build-up of sediment higher than the invert level of the culvert in the entrance area, would significantly improve water quality in the canal. Further, bank stabilisation and erosion control works at the mouth of the canal may assist in reducing the need for dredging (Appendix A).

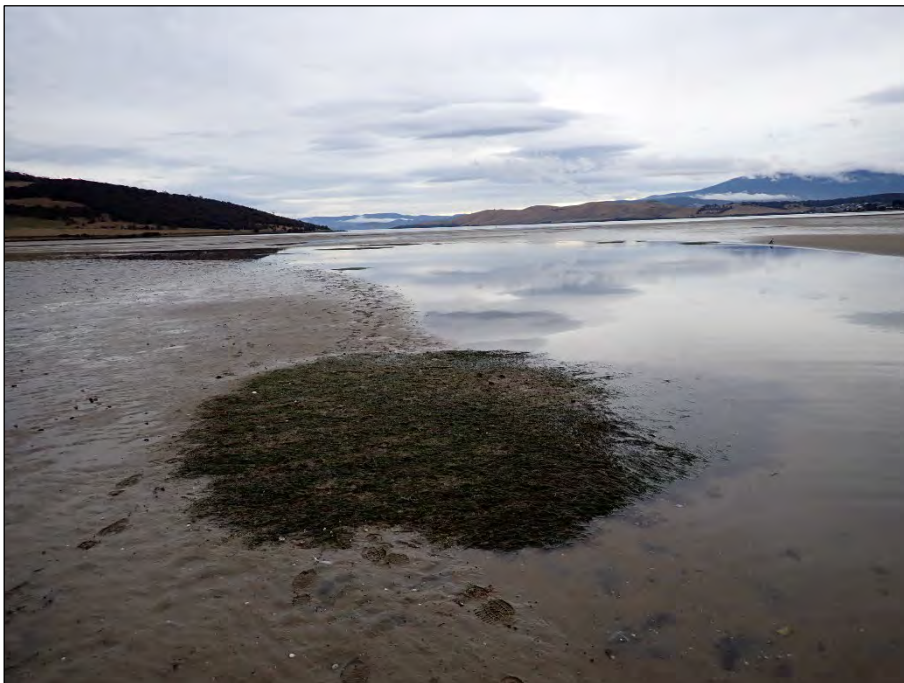
Isolated patches of seagrass (likely *Nanozostera muelleri*) were observed in the Ralphs Bay outside of the mouth of the canal (Figure 1.2), but no seagrass was recorded in the canal.

Figure 1.2 Isolated patch of seagrass in Ralphs Bay.

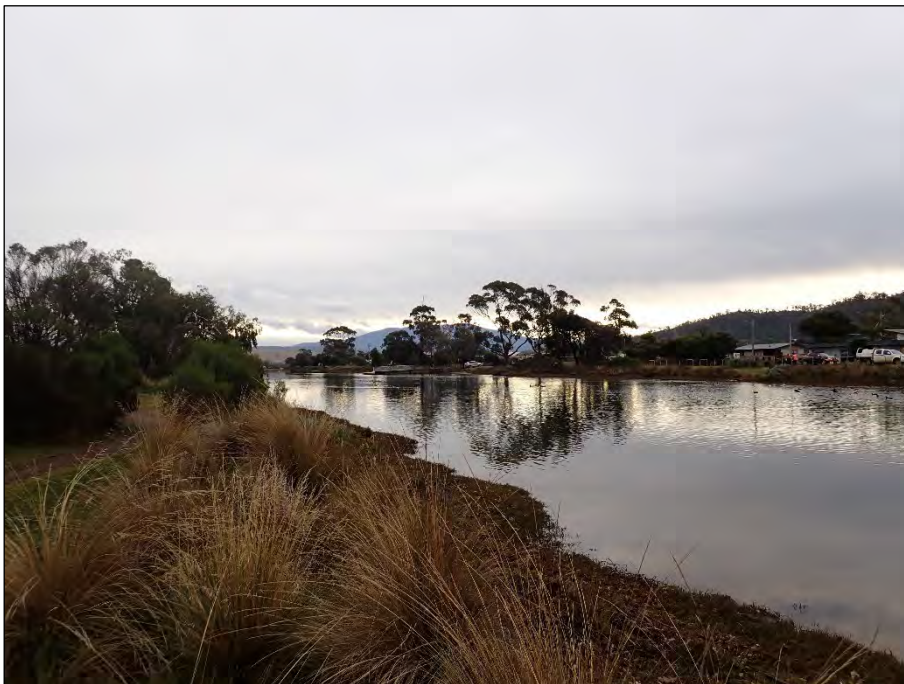
Riparian vegetation of the canal is dominated by native saltmarsh species at the water's edge (Figure 1.3), transitioning to planted native gardens with exotic species higher on the banks.

Figure 1.3 Riparian vegetation dominated by native saltmarsh species.

Riparian species included *Distichlis distichophylla* (Australian salt-grass), *Austrostipa stipoides* (coastal spear grass), *Juncus kraussii* (sea rush), *Ficinia nodosa* (club rush), *Samolus repens* (creeping brookweed), *Sarcocornia quinqueflora* (samphire), *Plantago coronopus* (buck's horn plantain), *Tecticornia arbuscula* (shrubby glasswort), *Suaeda australis* (seablite), *Atriplex cinerea* (grey saltbush), *Tetragonia implexicoma* (ice-plant), *Carpobrotus rossii* (pigface), *Osteospermum fruticosum* (African daisy), *Gazania linearis* (gazania), *Acacia* spp., *Casuarina* spp. and *Eucalyptus* spp.

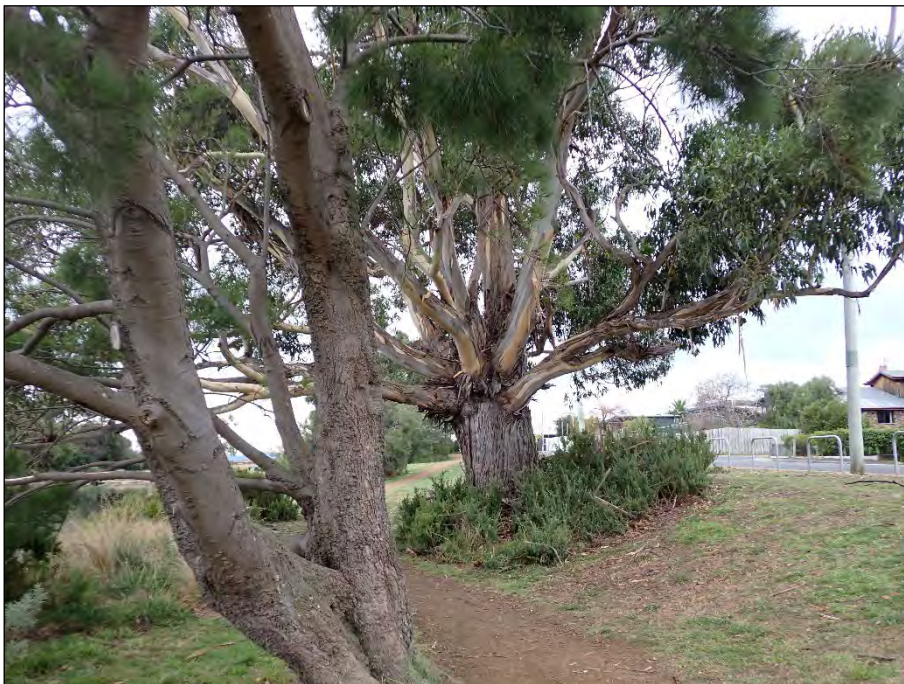
Vegetation higher on the slope from the riparian vegetation was dominated by areas of mown grass with scattered large Eucalypts, Casuarina and Acacia, and maintained gardens (Figure 1.4).

Figure 1.4 Recreational open space areas surrounding the canal.

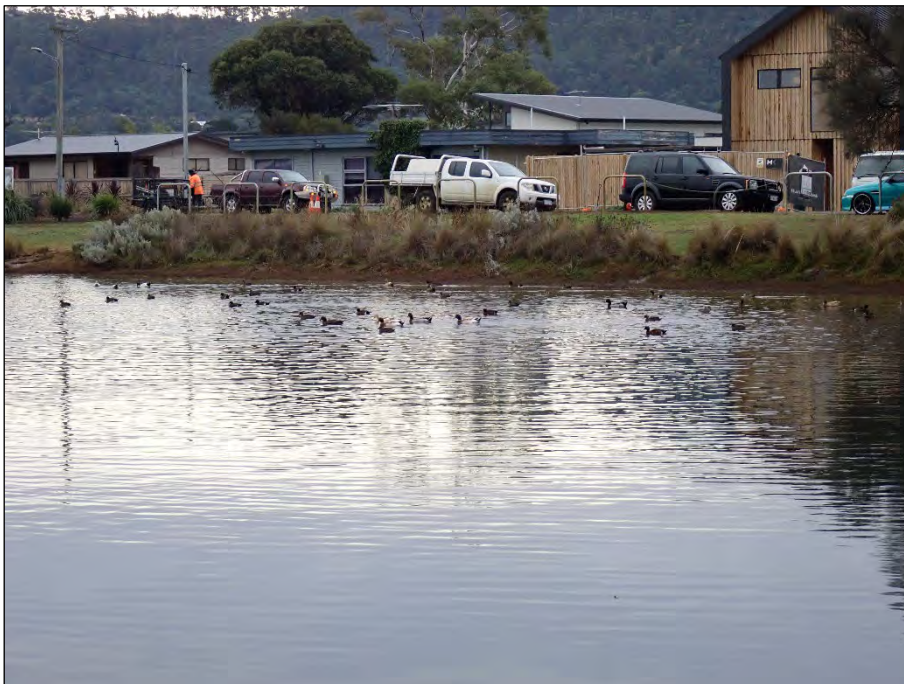
Crustaceans and molluscs were observed on all submerged hard structures within the canal. A number of water birds were observed using the canal to forage and nest (Figure 1.5).

Figure 1.5 Water birds using the canal.

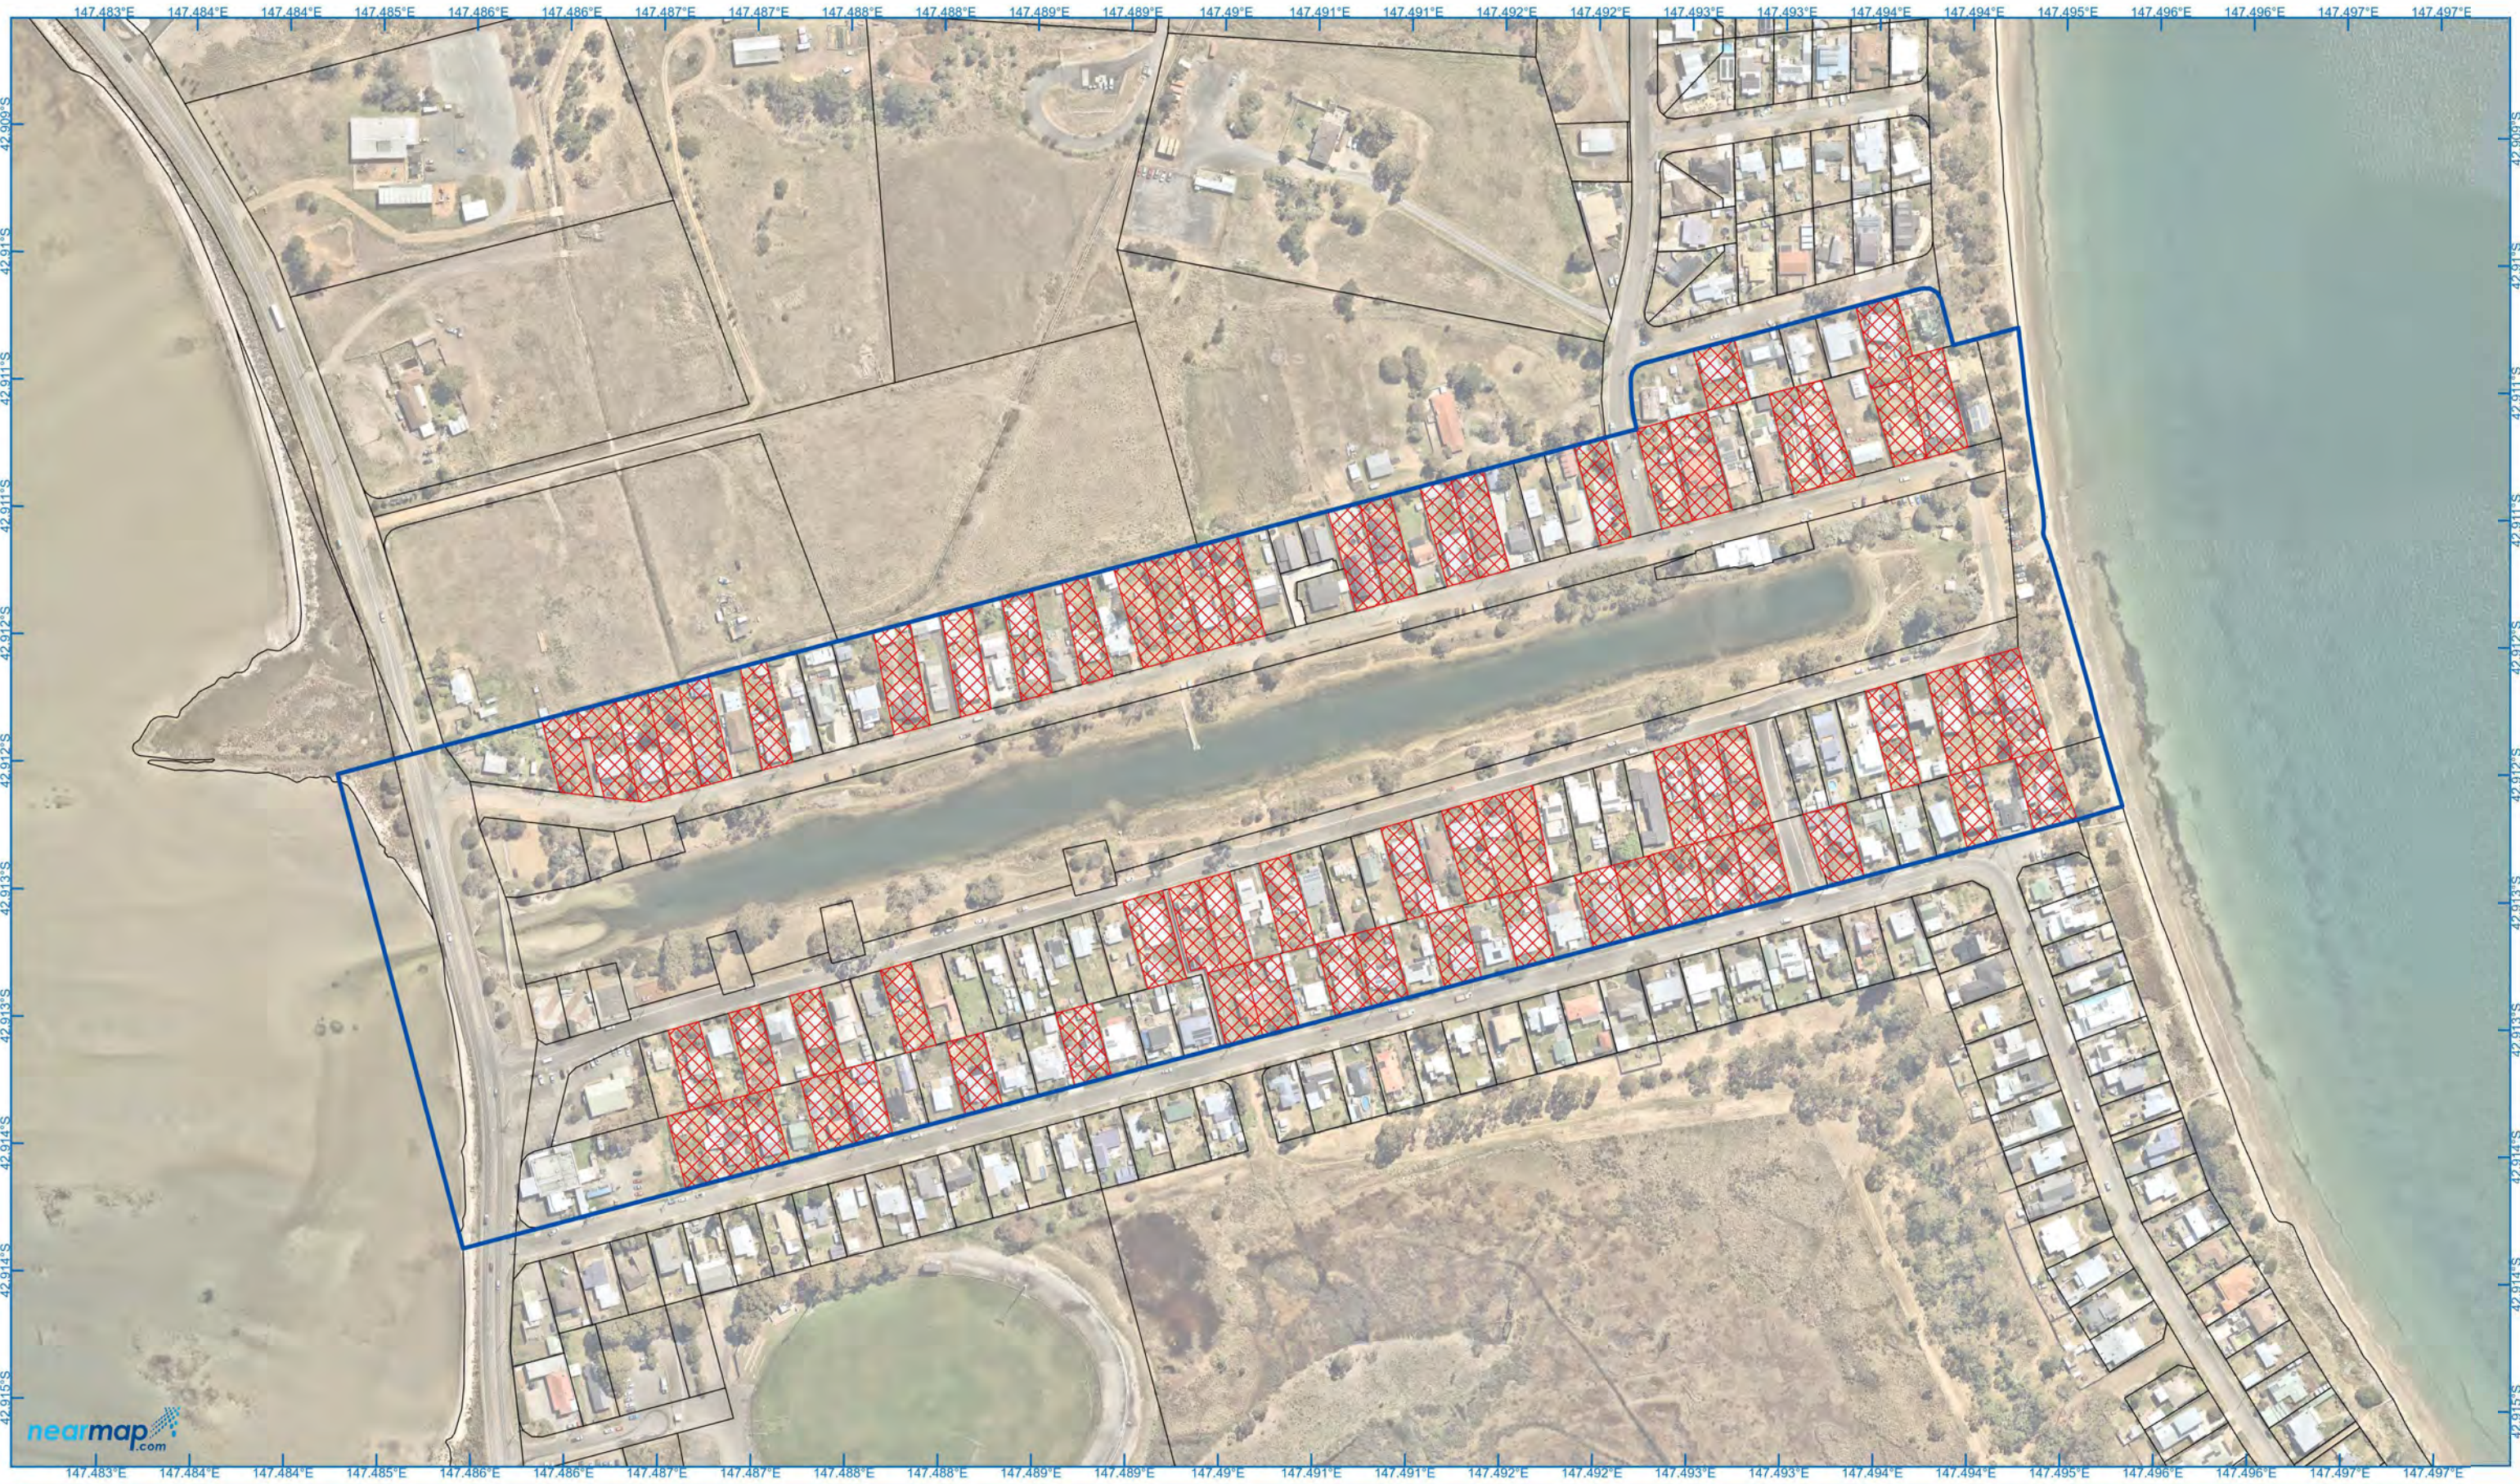
Map 2.1: Potential Properties Serviced by Septic Tank.

A potential source of nutrients in the canal are the septic systems associated with residential properties (Map 2.1). As septic tanks age and degrade, the likelihood of them leaking into the surrounding environment increases. Routine maintenance is also required so that tanks do not overflow. As the area is redeveloped it is likely that properties will be connected to the sewage system reducing this risk.

- connection of more houses to the sewage system, starting from the upstream lots
- servicing and upgrading the existing septic systems, and
- direct upstream stormwater to pipe flowing east to Roches Beach, and downstream to just inside connection to Ralphs Bay – to reduce e-folding time and also assist in keeping the canal clear.

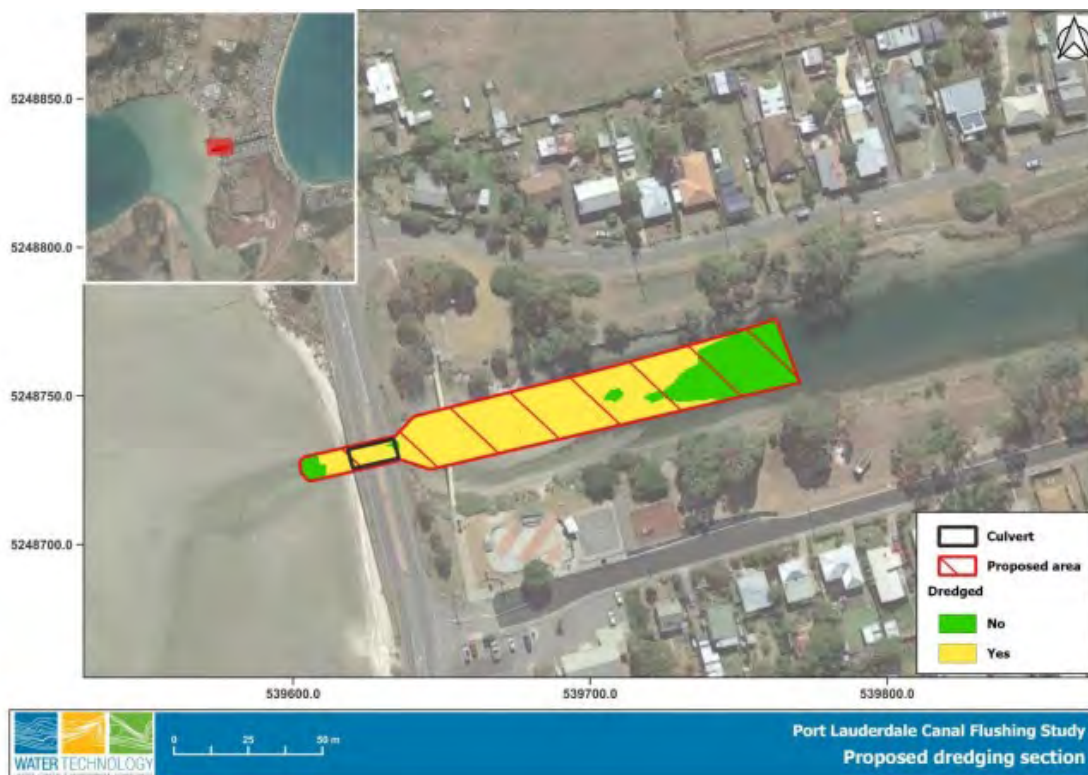
The base model simulation represents existing tidal flushing conditions within the Lauderdale Canal using surveyed bathymetry, and was used to understand the hydrodynamics within the canal. To assess the potential to improve tidal flushing in the canal, a second scenario (test case) was simulated. The test case simulated the impact of removing approximately 200 cubic metres from the entrance to the canal (Figure 3.1), with all material above -0.3 m AHD (corresponding to the existing levels in the Ralphs Bay Conservation Area) removed from this area (Appendix A).

Figure 3.1 Proposed area of sediment to be removed.

- Sediment buildup governs water flow during ebb-tide under the culvert/bridge.

- Tidal flow appears to be severely restricted, therefore limiting water flow in and out of the canal when the water level drops to the level of sediment buildup.

- The restricted tidal flushing, especially in the upstream reaches, is a likely contributor to the poor water quality in the canal.
- By dredging the canal entrance, tidal flushing in the canal is significantly improved, even for very low water levels.

Sediment could be removed either using a dredge or backhoe operated from the bank. Prior to removal and disposal, the sediment should be tested for contaminants and acid sulfate potential (ASS). Where it is anticipated the sediment will be disposed of underwater, contaminants should be assessed according to the National Assessment Guidelines for Dredging 2009 (NADG; Commonwealth of Australia 2019) and where it may be disposed of on land, according to the National Environment Protection (Assessment of Site Contamination) Measure 1999 (ASC NEPM; Australian Government 2013) soil guideline. Noting that the trigger values in these two protocols are largely the same, but there are slight differences in assessment methods. Acid sulfate potential should be assessed according to the latest version of the Australian guidelines (Sullivan et al. 2018a and 2018b).
